The Fujita Tornado Intensity Scale: A Reassessment from Structural Engineering Perspective

Long T. Phan¹ and Emil Simiu²

Wind and Seismic Effects. U.S./Japan Natural Resources Development Program (UJNR). Joint Meeting, 31st. Technical Memorandum of PWRI 3653. Proceedings. May 11-14, 1999, Tsukuba, Japan, 469-474 pp, 1999.

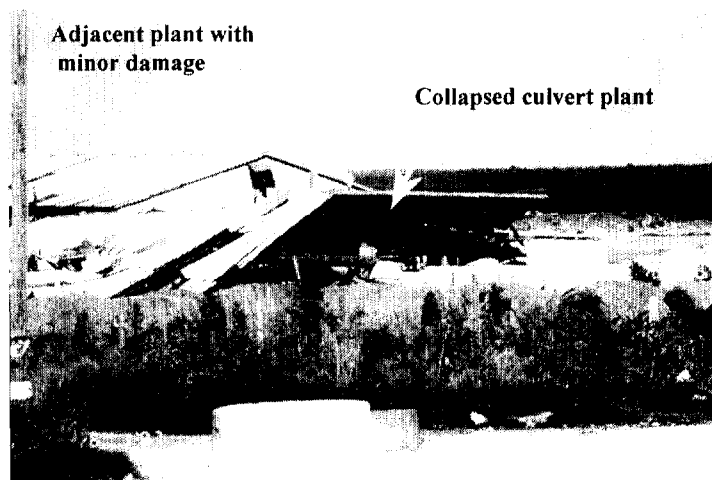
The first structural damage in Jarrell occurred at the corner of County Road 305 and County Road 307, where a culvert plant collapsed in place (Figure 1). The plant was a light steel frame construction with non-reinforced masonry and steel tube columns supporting steel pipe, gable roof trusses. The steel tube columns were cast into a concrete mat foundation on grade. The roofing, supported by wood purlins, consisted of corrugated sheet metal. An identical plant located approximately 15 m away from the collapsed culvert plant, and a mobile home located about 150 m north-northwest of the plant sustained only very minor damage. As the tornado continued its track south-southwestward, a barn located just southwest of the culvert plant and just north of the Double Creek Estates subdivision in Jarrell was destroyed. The tornado then moved through the Double Creek Estates subdivision and the surrounding areas, where the destructive path widened to its maximum of 1.2 km and the tornado became most deadly.

Figure 1. Ground view of collapsed culvert plant.

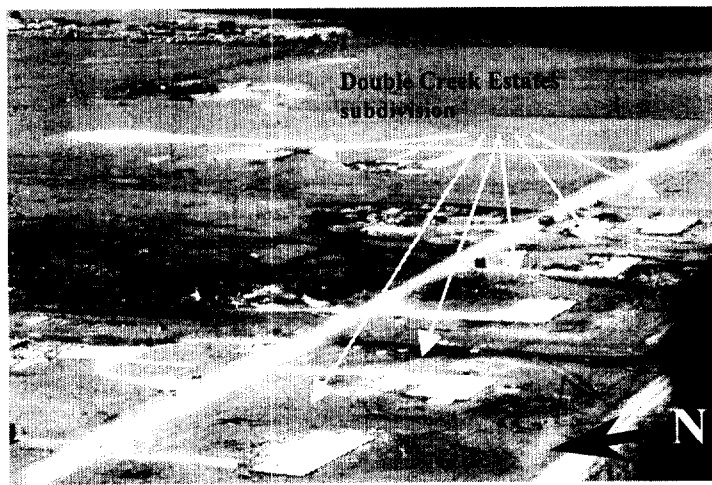
Figure 2 shows a portion of what remained of Double Creek Estates subdivision after the tornado passage. The structures in the subdivision consisted mainly of single family residences built over the last 15 years or so, of the typical slab-on-grade construction type. Owing to the presence of a limestone bedrock most houses had no basements or underground shelters. The houses, which consisted mainly of wood frame construction, were completely swept off the concrete foundations. Inspections of the concrete

Figure 2. Aerial view of portion of the Double Creek Estates subdivision after tornado passage

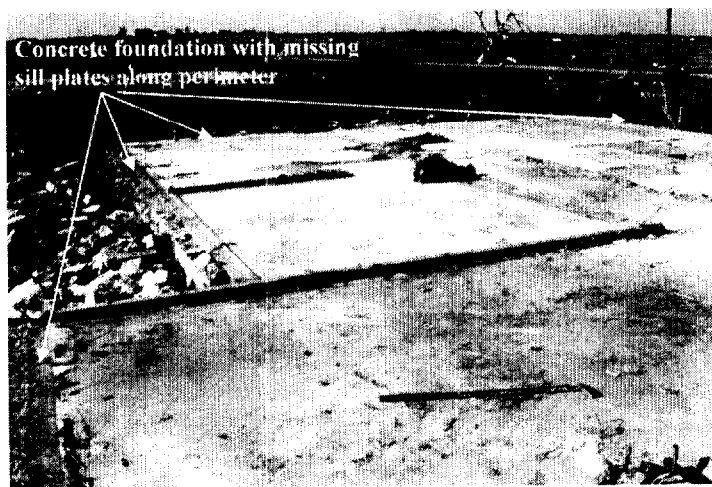
slab-on-grade foundations performed during the ground surveys revealed that, in many cases, even the sill plates that connect the wood frames to the concrete slab-on-grade foundations were blown away (see Figure 3). There was evidence that the sill plates had been connected to the foundations by explosive-driven nails. Figure 4 shows a nail that remained in the foundation but pulled through the sill plate. Figure 5 shows nails, spaced 0.9 m apart, that pulled out of the foundation. The Council of American Building Officials (CABO): One and Two Family Dwelling Code and other nationally recognized model codes require that sill plates of exterior walls for wood-frame construction be anchored to the foundation by anchor bolts not more than 1.83 m apart, but no evidence of anchor bolts was found by the team. It should be noted that Williamson County *has not adopted a building code*, even though Jarrell was also hit by a tornado on May 17, 1989.

Figure 3. Close-up view of a typical slab-on-grade foundation of houses in Jarrell. Only one sill plate remains connected to the concrete foundation.

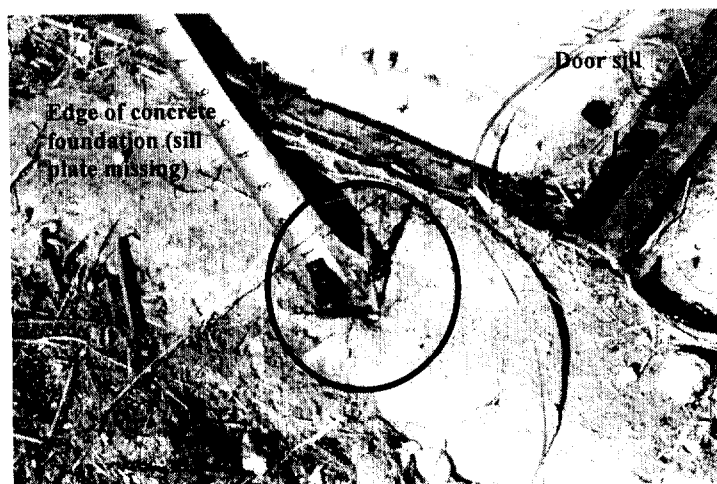
Figure 4. Evidence of nail that was used for connecting sill plate to concrete foundation.

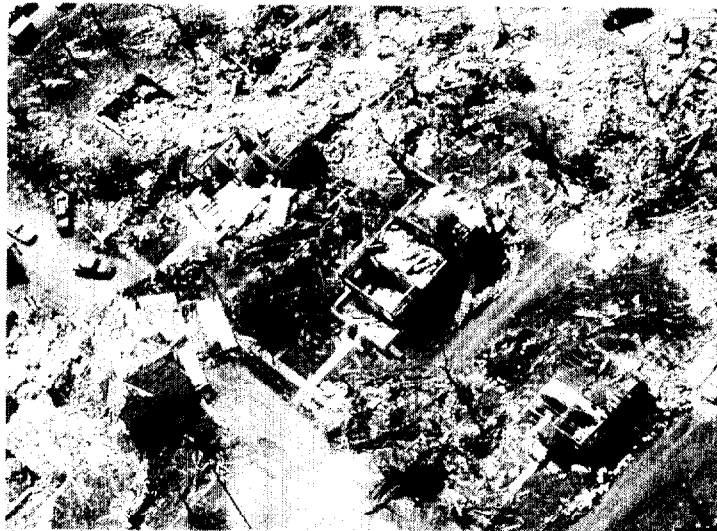
Figure 6 shows an overview of the town of Spencer after the tornado passage. Within the town of Spencer, the observed damage ranged from total disintegration of structures in the direct path of the tornado, to light damage to envelopes of structures in the outlying areas. The structures affected varied in age and structural systems. Completely destroyed structures included one and two-story wood-frame, heavy timber, and engineered metal frame constructions. Among these were wood-frame constructions that were either poorly connected or totally unconnected (i.e., relying on gravity alone) to the concrete or brick foundations. However, structures that were totally destroyed also included some (post office, fire department, gas station, antique and other stores) that were properly anchored to the concrete slab-on-grade foundations by 12.7 mm ($\frac{1}{2}$ -in) anchor bolts with proper spacing as required by CABO (1995) and other nationally recognized model codes (see Figures 7 (a) and (b)). Many heavy trucks, some reportedly fully loaded, used in transporting grains to and from the town's grain processing and storage warehouses, were lifted and carried more than 30 m away by the wind. Trucks and houses exhibited widespread evidence of missile impacts from broken wooden power poles, tree branches, and other debris.

Figure 6. Aerial view of portion of the town of Spencer, South Dakota, after tornado passage.

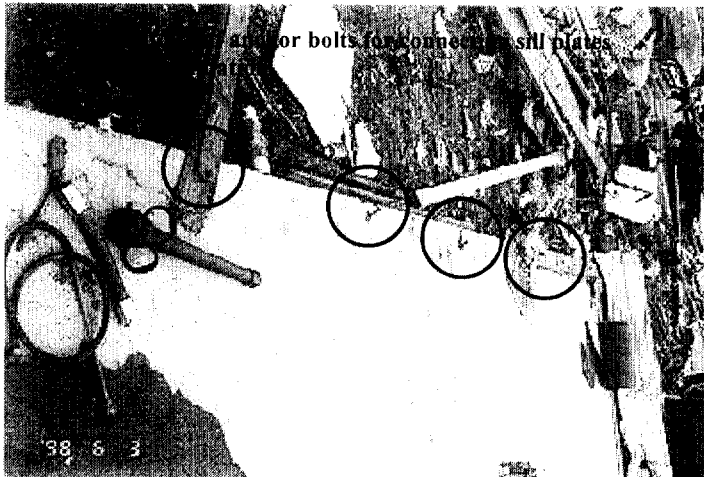
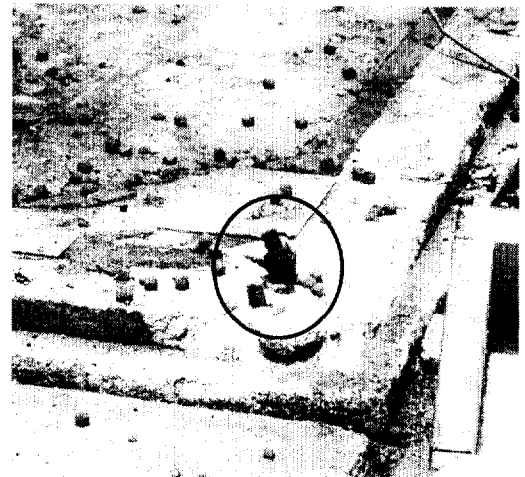
In fact, based on evidence that code compliance with respect to the connections between the upper wood frame and the concrete foundation was better in Spencer than in Jarrell, one may conclude that buildings that were completely destroyed were stronger in Spencer than in Jarrell. Nevertheless, the NWS tornado ratings were F5 and F4 for the Jarrell and Spencer tornadoes, respectively. In our opinion this is a clear indication of possible inconsistencies inherent in subjective tornado speed assessments by non-engineers.

Figures 7 (a) and (b). Evidence of anchor bolts used to connect upper structure to concrete slab-on-grade foundation in Spencer, South Dakota.
